# Assessment of the Effect of Pitting Corrosion on the Safe Life Prediction of the P-3C

DSTO-TR-2080

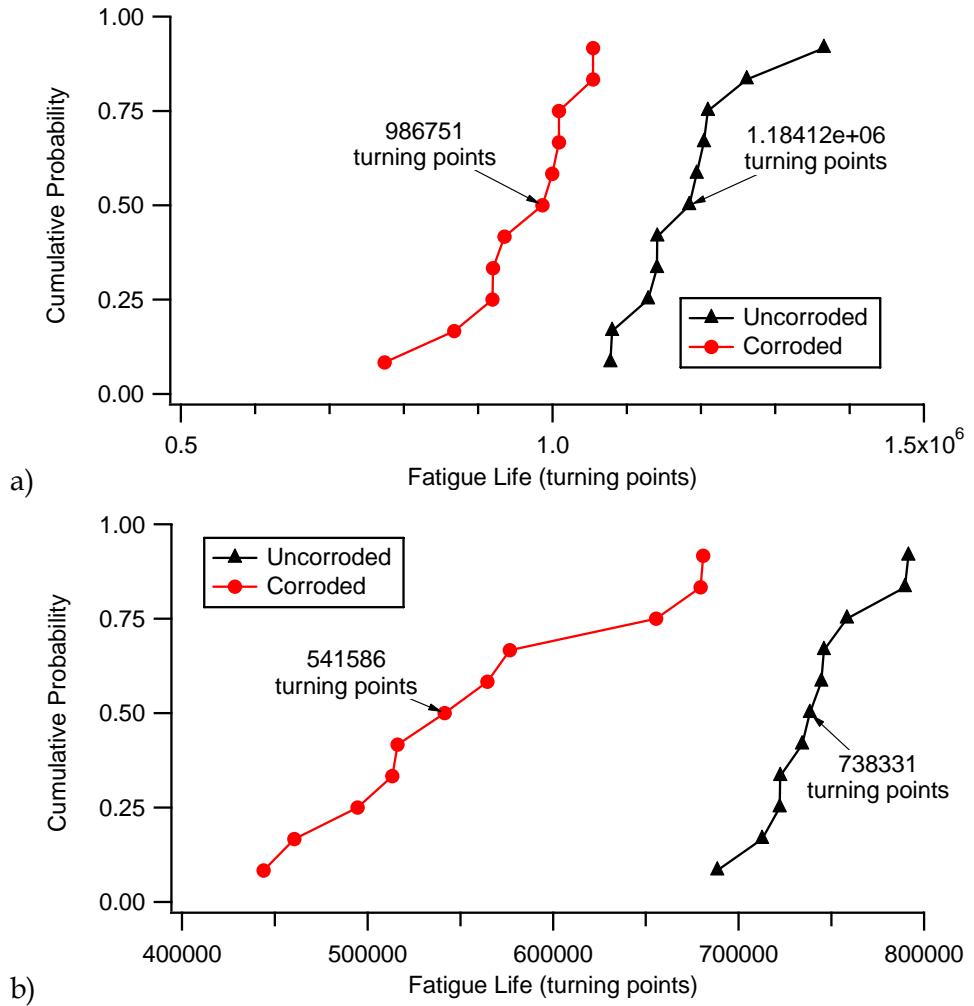
Figure 8: Effect of corrosion on fatigue life for (a) 15 kN and (b) 17 kN peak stress levels. Median fatigue lives for each corroded and uncorroded conditions are indicated.

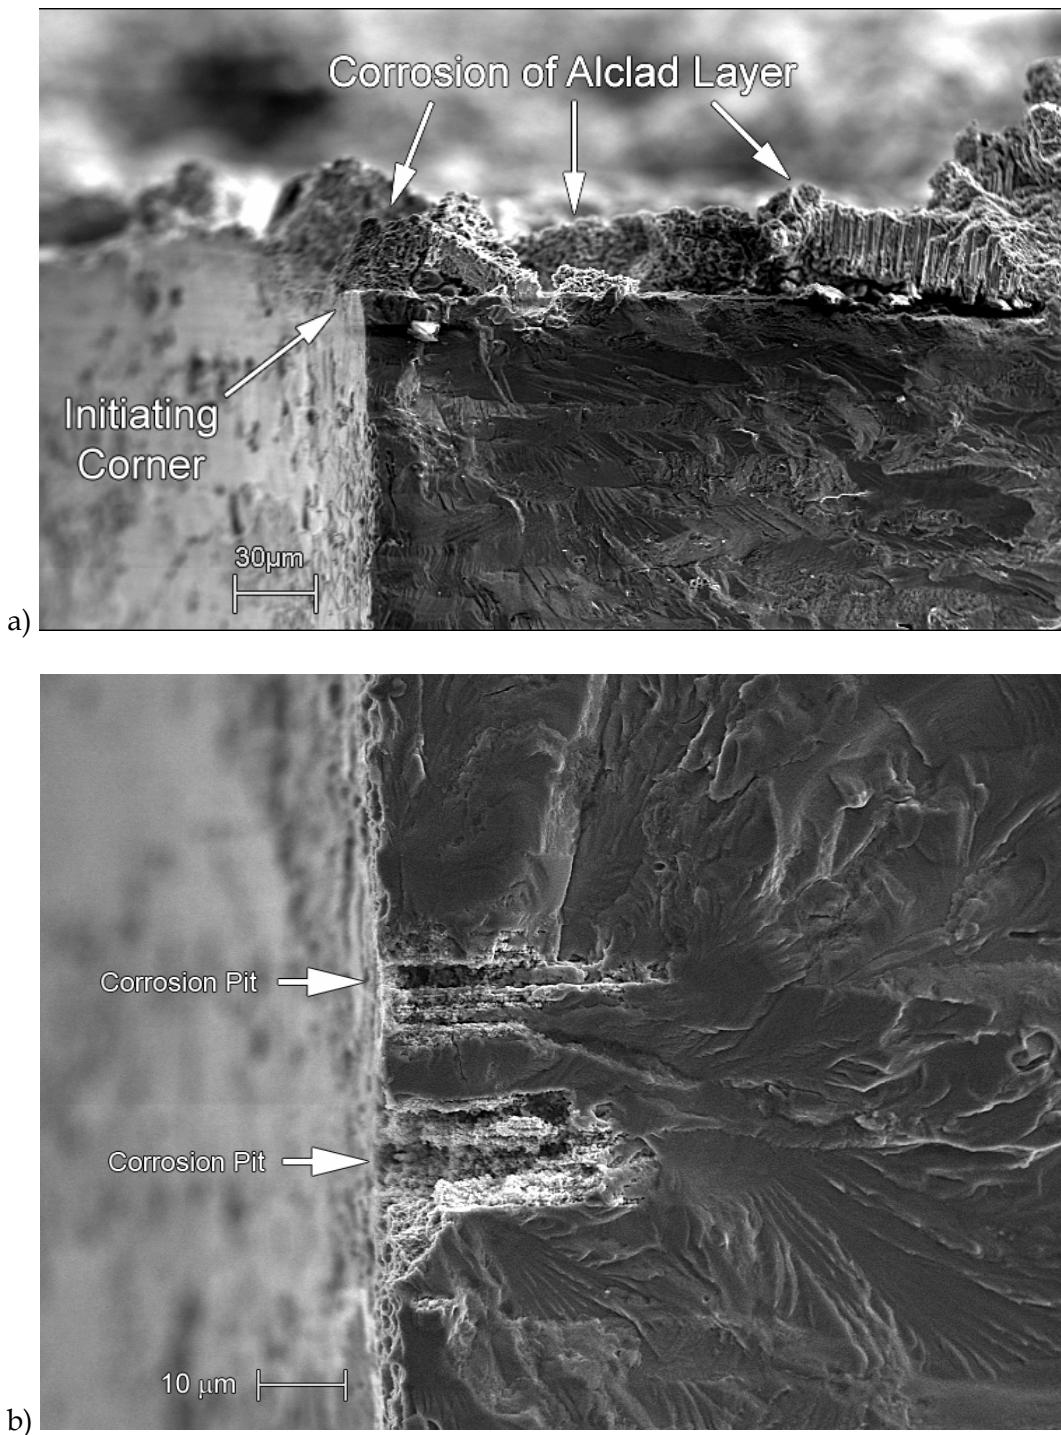
Fatigue initiation mechanisms were identified by fractographic examination of the corroded and un-corroded specimens in a scanning electron microscope (refer §4.3). Crack initiation occurred either at the corners of the stress concentrating hole or from corrosion pits. Corner failures occurred due to cracks initiated either within the softer Alclad material from machining defects, such as burring, at the corners of the specimens or through preferential corrosion of the Alclad layer. It is important to note that although the corrosion of the Alclad layer was many times larger than individual pits, typically encompassing the entire thickness of the Alclad layer, fatigue initiation via this mechanism was rare. Figure 9(a) shows an observed corner crack corrosion failure from the Alclad layer. A failure from a pit is shown in Figure 9(b) with river marks radiating from the corrosion pit. Figure 10 shows the mechanisms observed for the failure on the un-corroded specimens. Figure 10(a) shows a failure resulting from burring on the edge of the hole. Figure 10(b) shows the thickness of the Alclad layer and another example of burring.

Figure 9: Initiation sites associated with corrosion; (a) corner-initiated failure and (b) pit-initiated failure. Initiation sites are indicated by arrows.

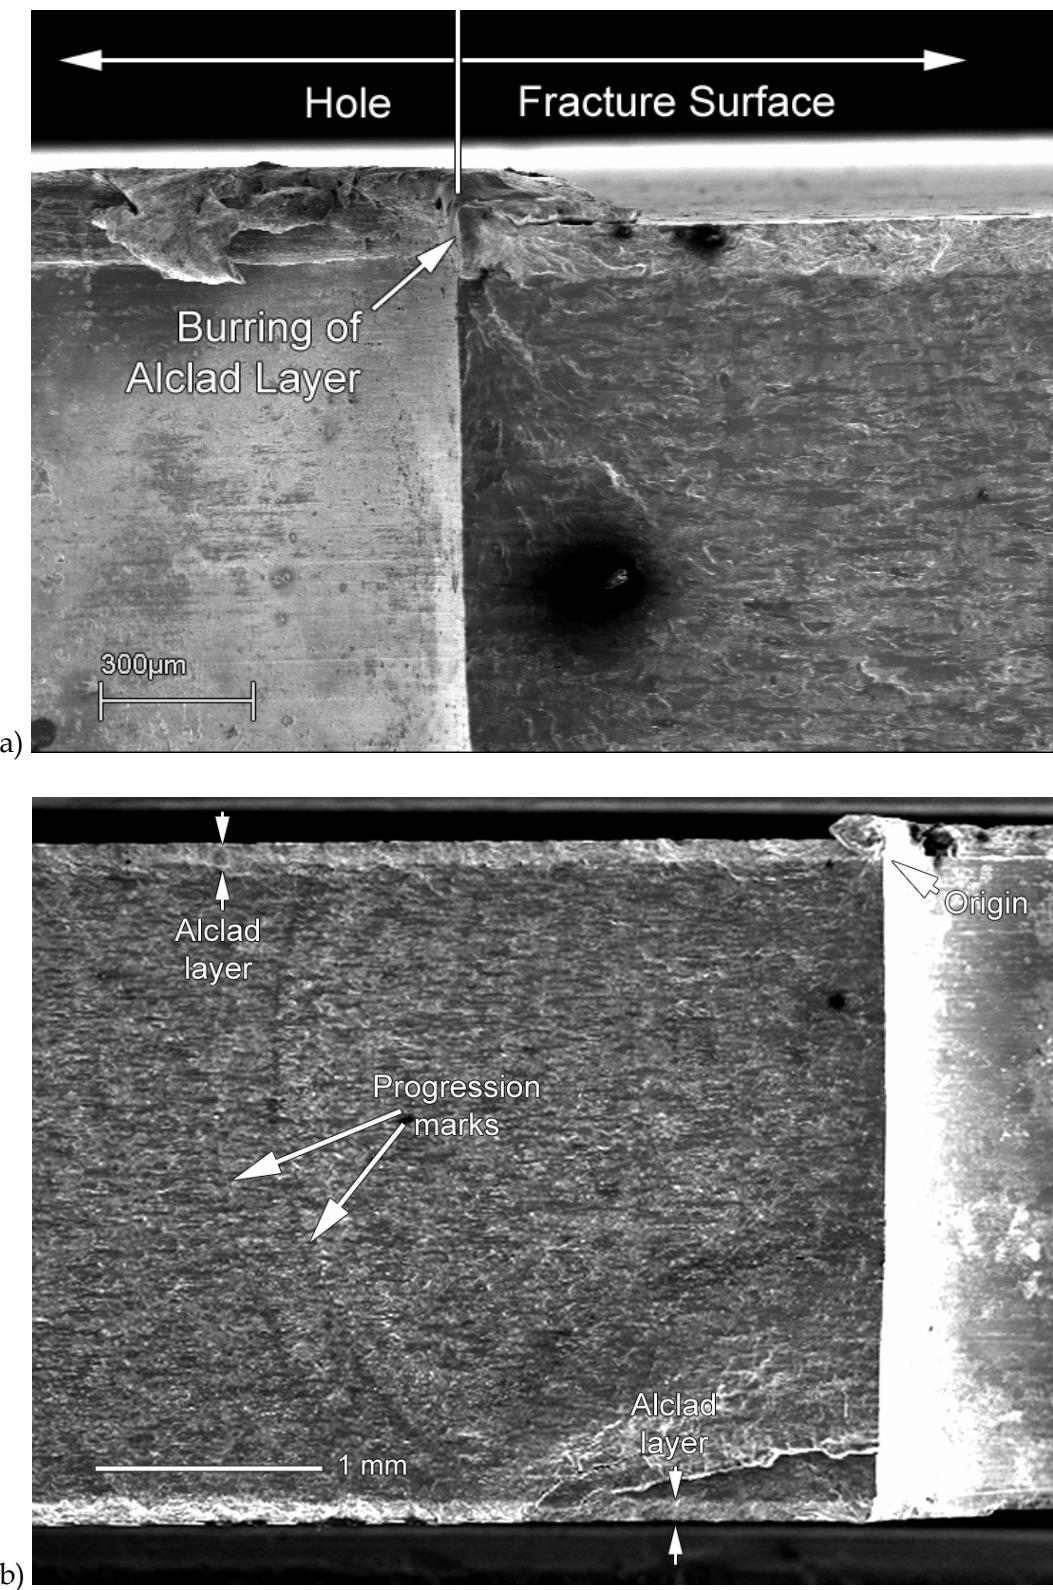
Figure 10: Initiation sites unrelated to corrosion; (a) Lapping/Burring and (b) Alclad layer and burring

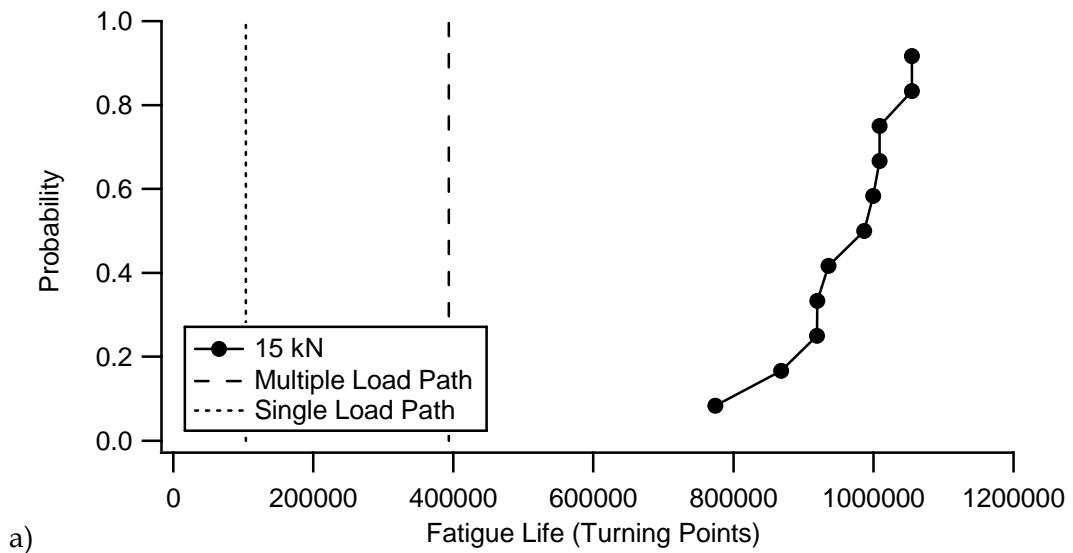
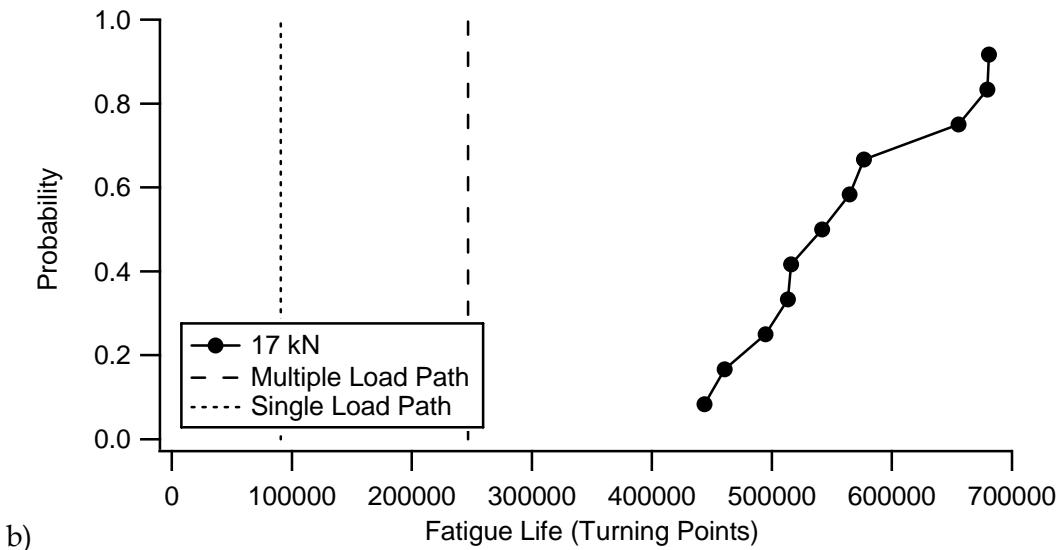
By comparing the threshold values of the safe-lives for single and multiple load path structure to the fatigue results for the corroded specimens, it is apparent that the corroded lives exceed the threshold values, Figure 17. The significance of the difference is difficult to determine however. The fatigue lives of the corroded samples for both 17 kN and 15 kN can be shown to follow a log normal distribution with a high degree of significance. The 17 kN results shown in Table 10 exclude the results from specimens that did not fail from corrosion. The high significances (greater than 0.05) indicate lognormal distributions.

Figure 17: Comparison of safe life estimates for single and multiple load path structure with fatigue results from corroded specimens for (a) 15 kN and (b) 17 kN peak load.

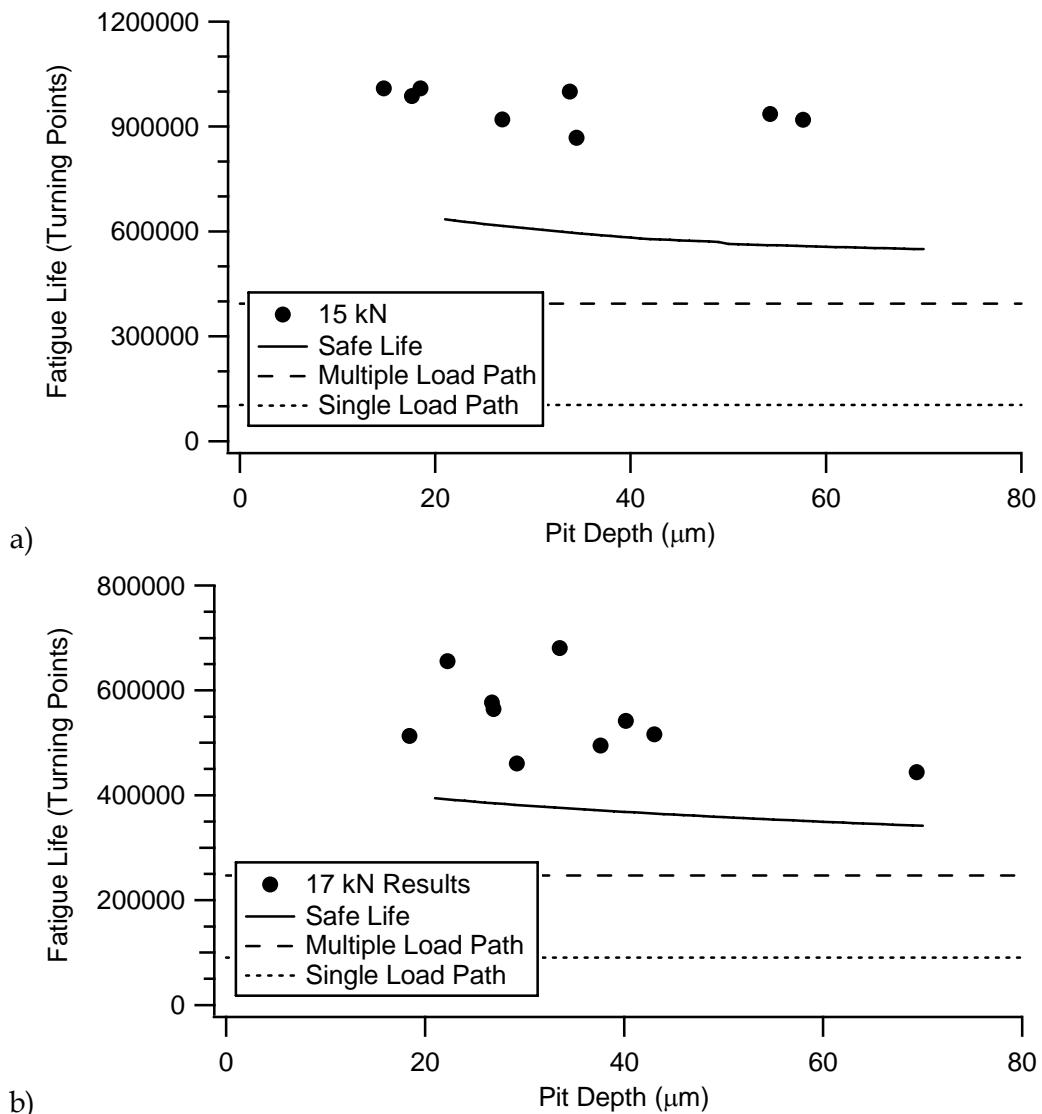
Fatigue lives predicted for the safe ECS values for both stress levels are shown in Figure 18. This figure also incorporates the crack initiation approach for P-3C SLAP. Threshold life values for both single and multiple load path structures were determined from the baseline fatigue tests using an interval between crack detection (crack reaching a size of 1.27 mm) and failure, provided by the FASTRAN model, Figure 14 and Figure 15. As can be seen, both at the low (15 kN), and the high (17 kN) stress levels corrosion pits, with a cross sectional area up to  $80 \mu\text{m}$  ( $6,400 \mu\text{m}^2$ ), will not result in failure prior to the threshold lives for both multiple and single load path structures.

Figure 18: Comparison between the predicted failure lives due to corrosion with the threshold (safe life) values using Crack Initiation predictions for (a) 15kN and (b) 17kN peak load
